Technology Demonstration Facility Case Study

AML Oceanographics Inc. - Anti-Biofouling System

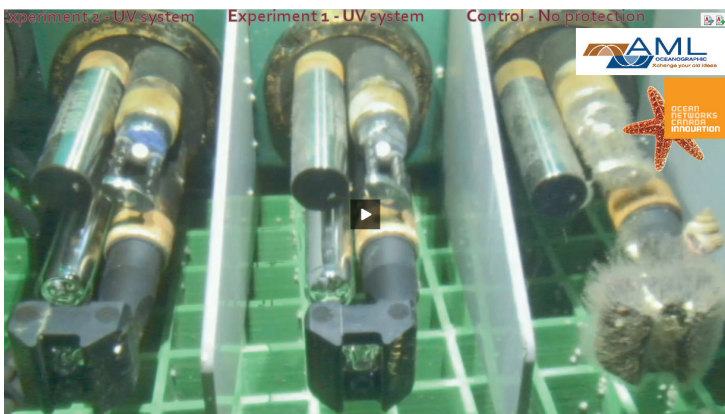
Day 66: heavy fouling on the control sensors renders them unuseable while the UV-protected experimental sensors are performing within specifications.

In October 2013, two UV protected AML Oceanographic CTDs and one control unprotected AML Oceanographic CTD were installed on the ONC instrument platform at Folger Pinnacle in 23 m of water. A video camera with lights was also installed to visually monitor the three CTDs. Thirty seconds of video were captured at 9:00 am PDT each morning. Data was collected from the sensors (1x per sec.) for the duration of the experiment, to assess the impact of biofouling.

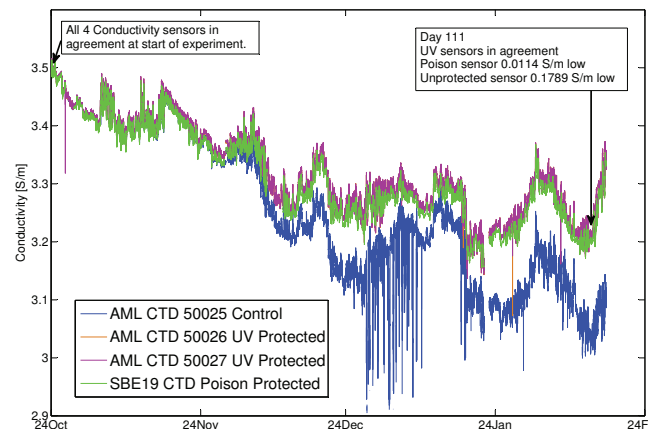
Conductivity data over time due to biofouling (in blue).
