Delta Cable is Back for Repair ^[1]

Submitted by Rory Lattimer Thu, 2012-10-18 00:00

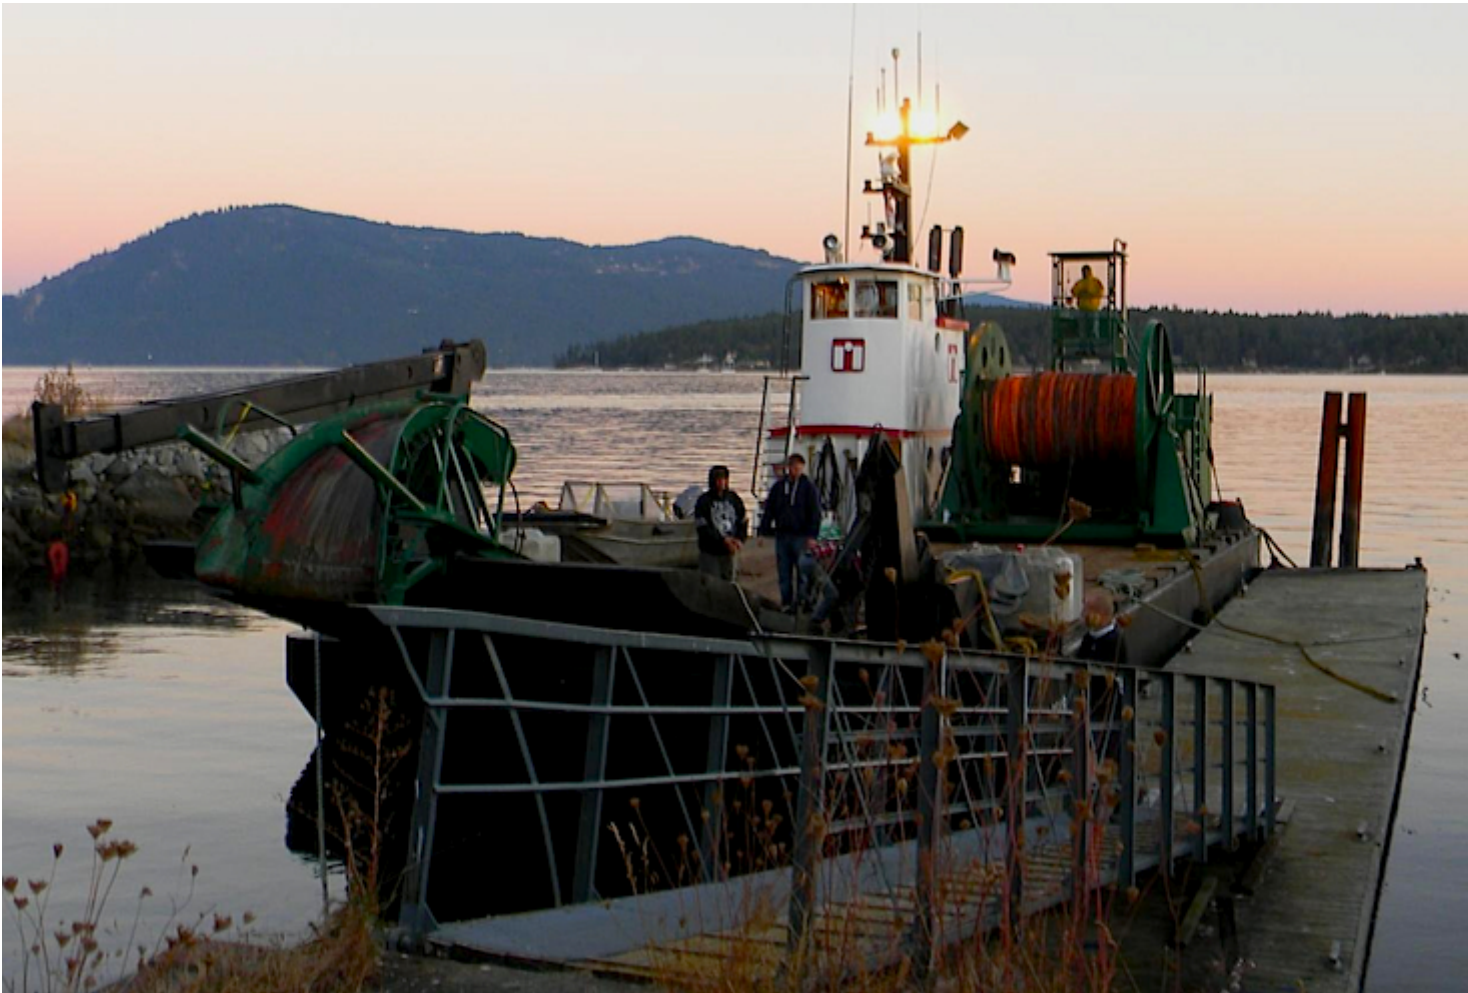
[2]

The orange reel holds over 5 km of extension cable on the deck of the ?Georgia Transporter? powered barge after a successful recovery. This cable supplies power and a communication link from the East Node in the Strait of Georgia (175m) to an instrument platform near the mouth of the Fraser River. This cable was damaged in June 2012 by an underwater landslide and will be repaired and then redeployed in April 2013.
